**NASA TM X-3508**

**EXPERIMENTAL APPARATUS  
FOR INVESTIGATION OF FAN  
AEROELASTIC INSTABILITIES  
IN TURBOMACHINERY**

*William H. Jones, Walter A. Bishop,  
Thomas A. Kirchgessner, and John H. Dicus  
Lewis Research Center  
Cleveland, Ohio 44135*

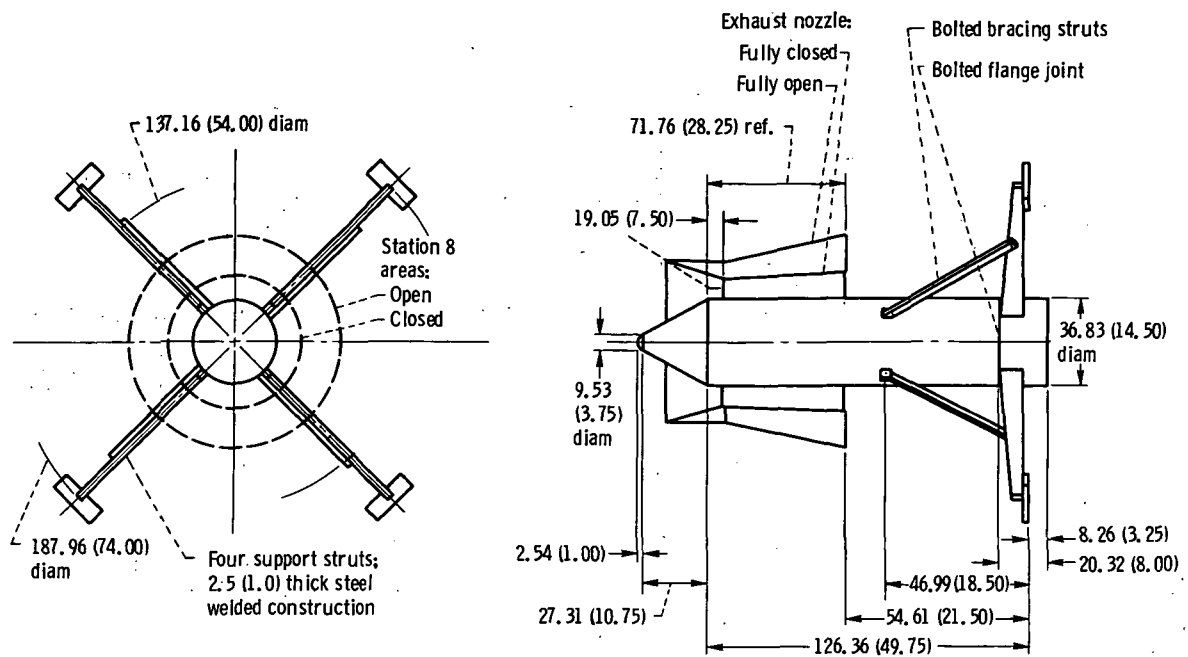
station 8. It was experimentally determined that this configuration would not permit proper operation of the pressure-balanced nozzle and that even normal scheduled exhaust areas could not be achieved. Further, it was noted that, at the minimum achievable area condition, considerable distortion of the exhaust nozzle leaves was occurring. The shallow penetration of the plug into the nozzle caused adverse pressure distributions to form inside the nozzle, thus overpowering the actuators and causing distortion of the nozzle leaves.

The plug was reconfigured to increase the penetration of the plug to bring the front of the constant-area section of the plug to 19.05 centimeters ahead of station 8 (see fig. 3). Later testing demonstrated that this configuration allowed full and effective control of the exhaust nozzle into the desired regions.

Figure 3. - Exhaust nozzle plug - stretched. (Notes: Dimensions are nominal in cm (in.). Drawing not to scale.)

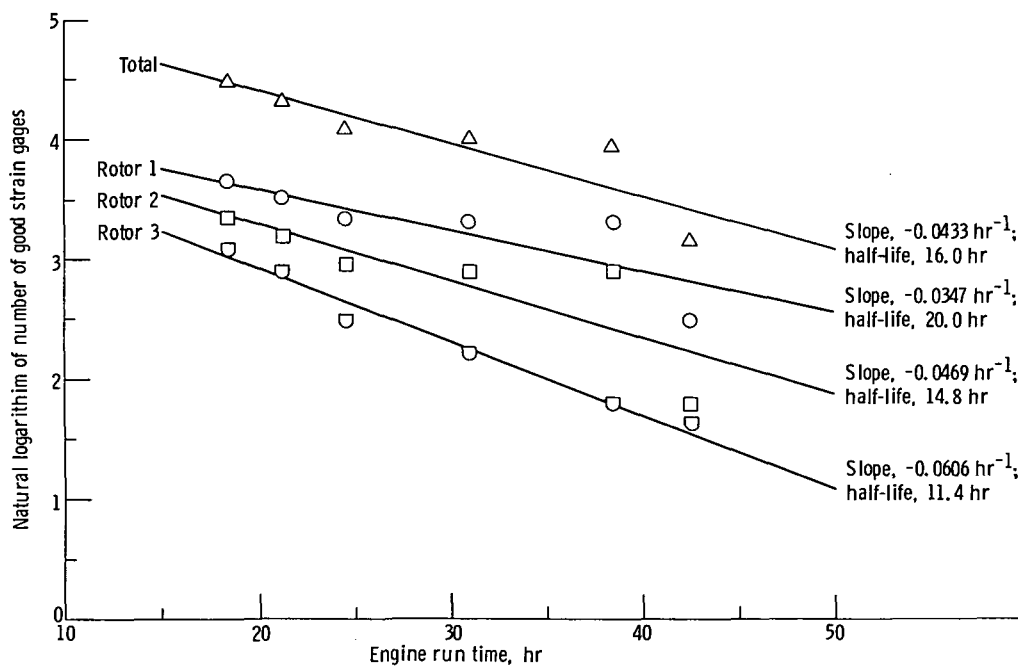
Strain-gage mortality was of concern to both current and future testing; therefore, records of strain-gage failures were kept. Tables II and III, for rotating strain gages only, are examples of the kinds of records kept. Figure 12 is a semilog plot of strain-gage mortality as a function of run time. From this figure one can deduce an approximate half-life for the strain gages of about 16 hours; however, the wide data scatter throws considerable suspicion on both the value of the calculated number and on the validity of the exponential decay model in describing the failures. Thus, it should be recognized that the half-life value is offered solely as a rough guide in the absence of a more comprehensive performance index.

Figure 12. - Absolute mortality of strain gages against elapsed engine run time.

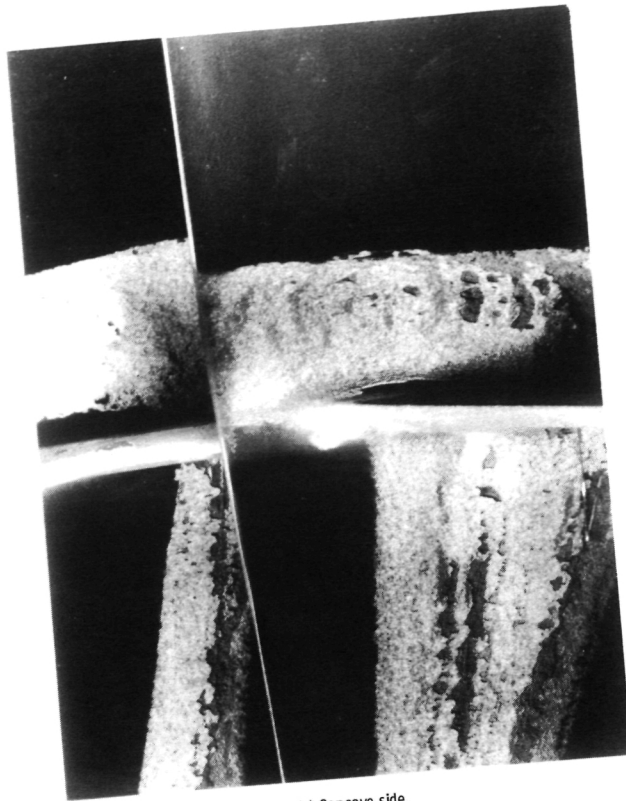
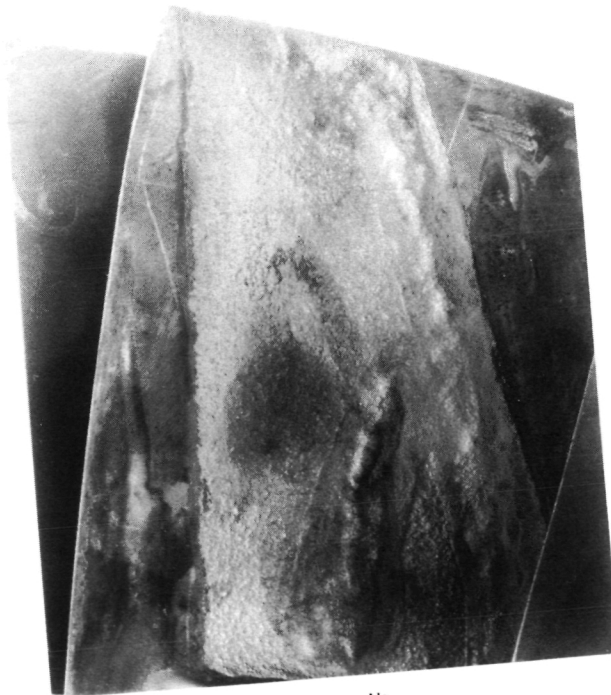
As is shown in figure 13(a), the predominant identifiable failure was caused by the erosion of the aluminum oxide flame-spray outer coating on the lead wires and the attendant debonding of the lead wires, followed by a disruption of the nickel-ribbon lead-wire circuit. Of main concern is the source of the erosion and/or debonding of the flame spray.

The theory first advanced was that the inlet air contained such a supply of dust, grit, and other foreign objects, such as rust scale, that the effect was like a continuous sandblasting of the coating which, consequently, removed the flame-spray coating and destroyed the strain-gage and/or lead-wire continuity. This theory cites as substantiation the photographically recorded fact that the erosion occurred primarily on the concave side of the blade (fig. 13(a)), where particles would naturally impact the surface, while the coatings on the convex side of the blade (fig. 13(b)) were relatively undamaged. Although it is known that the facility air-supply system contains rust and grit, no data are presently available concerning the size and quantity of the impurities.

A more careful study of figure 13 reveals the high level of erosion immediately over the lead wires and the lack of increasing spanwise severity toward the tip (due to higher relative "sandblasting" velocities). This suggests that the erosion was intensified by lumps in the coating caused by the presence of the lead wires.

With regard to a possible bond shortcoming, several points should be noted. First, there would appear to be an absence of bond between the underside of the ribbon lead wire to the flame-spray base coat. This in itself could be significant in that the flame spray over the lead wires was bonded only to the spaces between the lead wires. Second, one may reasonably expect some incompatibility in rigidity between the titanium blade, the aluminum oxide coating, and the nickel ribbon, which would lead to very high stresses in the nickel wire and possibly the aluminum oxide coating due to flexure and distance from the neutral axis. Also, such incompatibilities could lead to high interlaminar shear stress, which, in turn, could lead to debonding. Third, these difficulties would be aggravated by excessively thick aluminum oxide layers.

Figure 13. - Erosion of strain-gage and lead-wire coating on a first-rotor blade.

These points indicate that even with impurities in the inlet air, the life of the strain-gage installation can be increased by improving the bond quality (including bonding all sides of lead wires), by keeping flame-spray coatings thin and properly contoured and by seeking methods of relieving material rigidity incompatibilities.
